TS-950 S / SD/ SDX

Noise Repair Info

SERVICE BULLETIN AMATEUR RADIO

SUBJECT TS-950SD RX DIGITAL NOISE	DATE 01/17/90
--------------------------------------	------------------

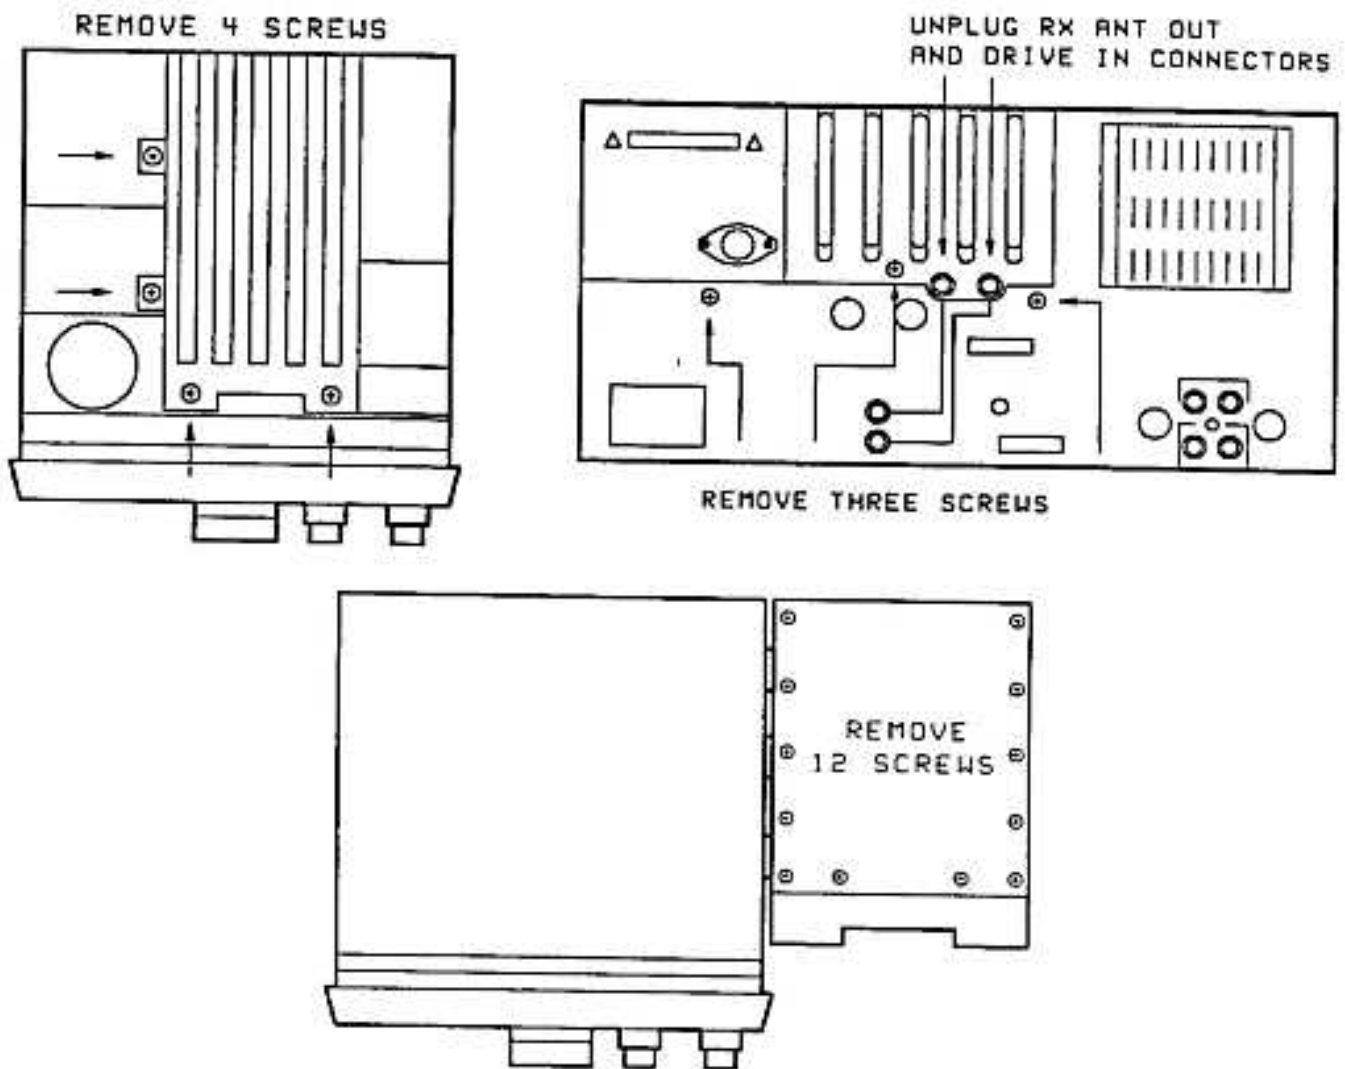
FIGURE 1

Some early TS-950SD transceivers may exhibit a low Signal to Noise ratio on ten and fifteen meters. In addition, rotating the encoder may allow the user to hear a crackling noise in his headphones. The following modification will correct this condition.

1. Disconnect the power cord and antenna.
2. Remove the top and bottom covers (18 screws).
3. Open the subchassis as shown in figure 1 (remove 4 top screws, remove 3 back panel screws, unplug the RX ANT OUT and DRIVE IN connectors).
4. Remove the cover from the subchassis (12 screws). FIGURE 1.
5. Remove the 9 screws from the Filter board.
6. Desolder the antenna connector wires at the antenna connector. Do not damage the surge absorber.
7. Rotate the Filter unit to expose the foil side of the board. Disconnect coax cables as necessary to rotate the board and remove the mesh plate as the board is rotated.
8. Cut the two ground foils as shown in figure 2.
9. Assemble the transceiver by reversing steps 1 - 7. Remember to install the mesh plate, resolder the antenna connector, and plug in the two connectors on the back panel.

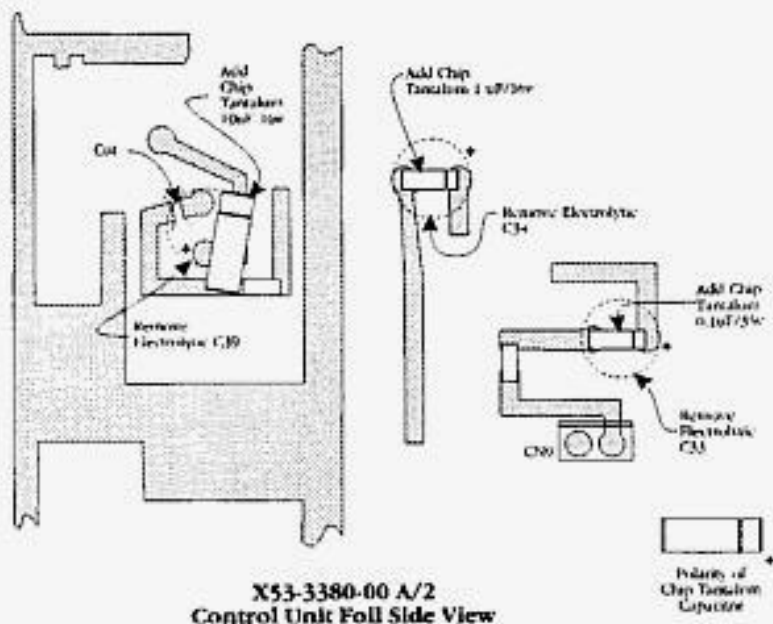
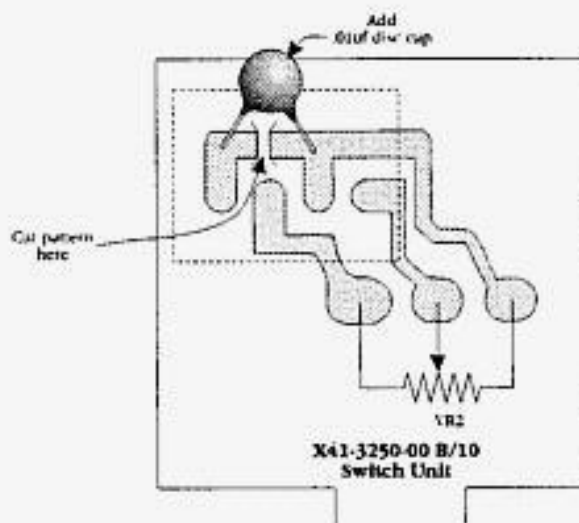
The level of residual noise (AF VOL at Min) on the SUB band is slightly higher than that of the MAIN band. This is especially true at audio frequencies of around 50 Hz, as viewed on a spectrum analyzer. As a result the SUB receiver is more susceptible to motor noise, such as might be generated by fans, refrigerators, etc.

Replacing the Control Unit electrolytic capacitors (C33, C34, and C39) with Tantalum capacitors, and adding the bypass capacitor to the Switch unit reduces or eliminates this symptom.

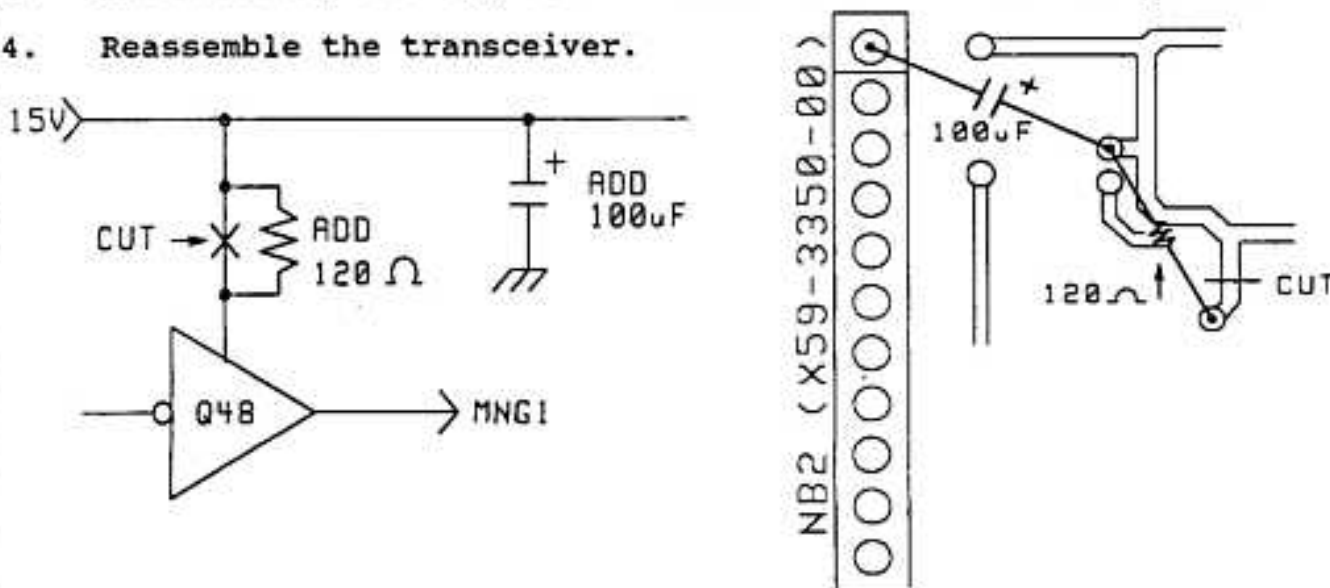
Switching noise from the main band noise blanker circuit may be induced on the 15V line and pass through the AF amplifier to the speaker. The following modification will correct this condition.

1. Cut the foil as shown in the accompanying diagram.
2. Add a 120 ohm resistor between the emitter of Q48 and the 15V line.
3. Add a 100uF, 16V capacitor between the 15V line and ground.
4. Reassemble the transceiver.
